4. TITLE (and Subtitle) Whiting River Dam  NATIONAL PROGRAM FOR INSPECTION OF NON-FEDERAL DAMS		5. TYPE OF REPORT & PERIOD COVERED INSPECTION REPORT
7. AUTHOR(s) U.S. ARMY CORPS OF ENGINEERS NEW ENGLAND DIVISION		6. PERFORMING ORG. REPORT NUMBER

NATIONAL PROGRAM OF  
INSPECTION OF  
NON-FED. DAMS

WHITING RIVER DAM
WHITING RIVER
NO. CANAAN, CONNECTICUT
CT 00483
17 NOV '80

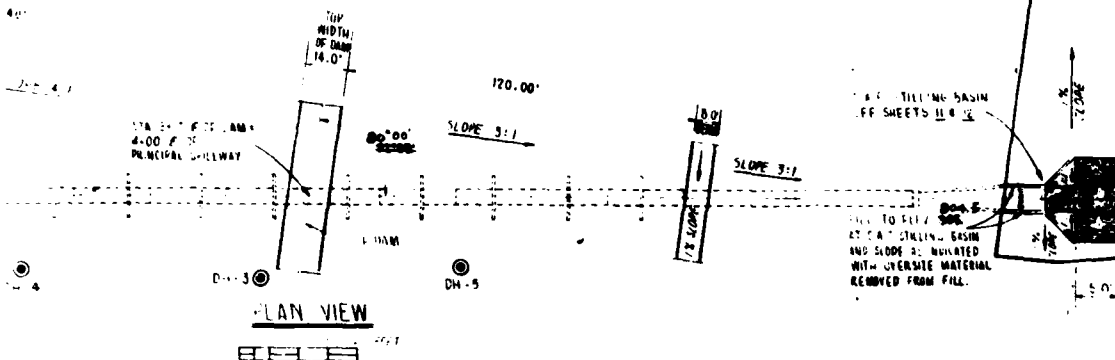
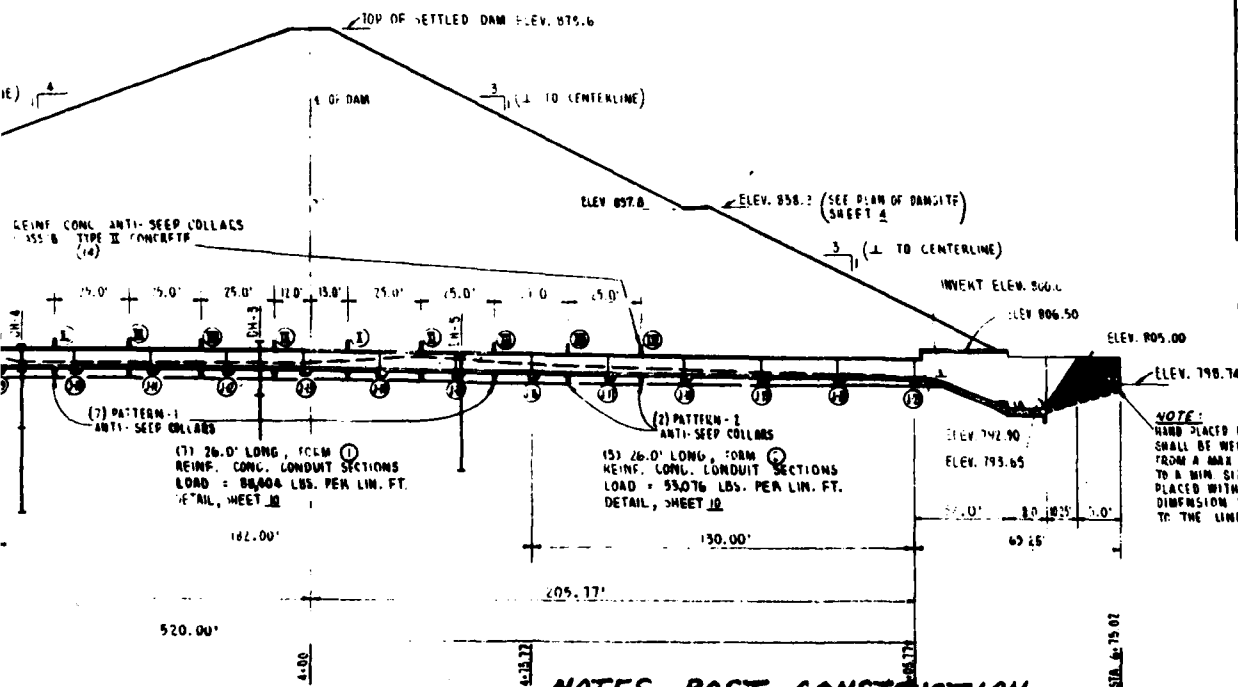
PROFILE ALONG & PRINCIPAL SPILLWAY

The drop inlet connects to a reinforced concrete conduit through the dam which discharges through an energy dissipator at the downstream toe. The conduit was not observed but it was reported that two internal cracks were observed in 1977. (See notes on Plan,

7/77 CONCRETE CRACKS 13.2' D.S. FROM J-15 AND 14'-16' D.S. FROM J-16
